WL-TR-91-4032
DOT/FAA/CT-91/23
VOL II, Part 2

COMPOSITE FAILURE ANALYSIS HANDBOOK
VOL II - TECHNICAL HANDBOOK
PART 2 - ATLAS OF FRACTOGRAPHS

R.J. Kar
Northrop Corporation
One Northrop Avenue
Hawthorne, California 90250-3277

February 1992

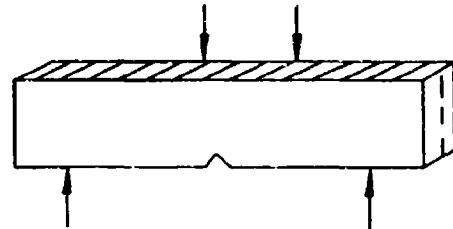
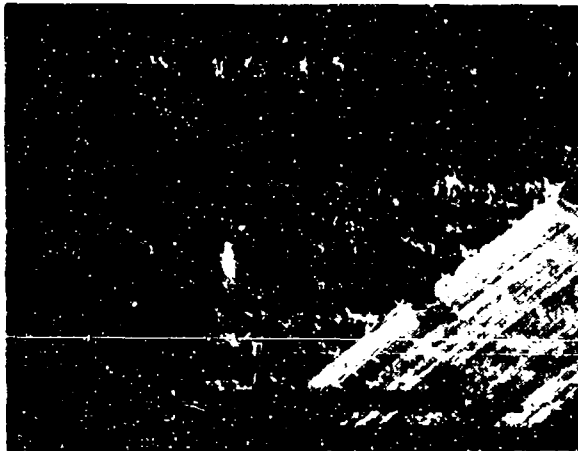
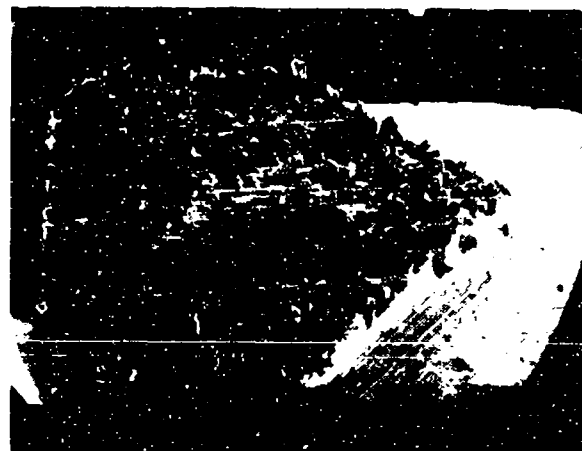
Fracture type	Translaminar mode I tension
Ply layup	[0, 90] 16S
Test type	Four-point bend
• Test conditions	Dry
• Fiber end fracture	
Material	Hercules 3501-6/177°C cure AS4 fibers

-65°F, dry

160°F, dry

270°F, dry

Figure 2-130. SEM Photographs of Translaminar Mode I Tension, 0/90 Fracture, -65, 180, and 270 F/Dry (Low Magnification)

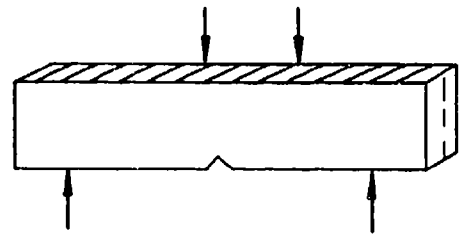
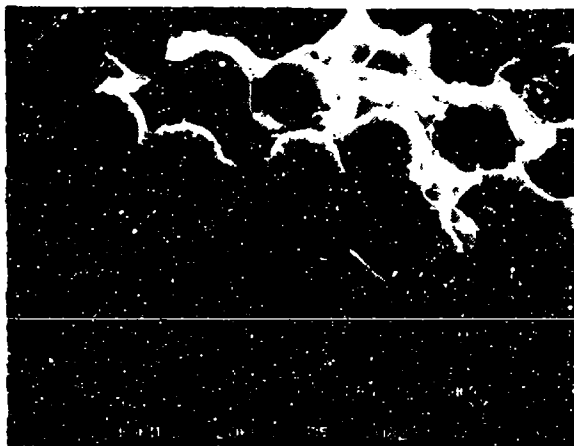
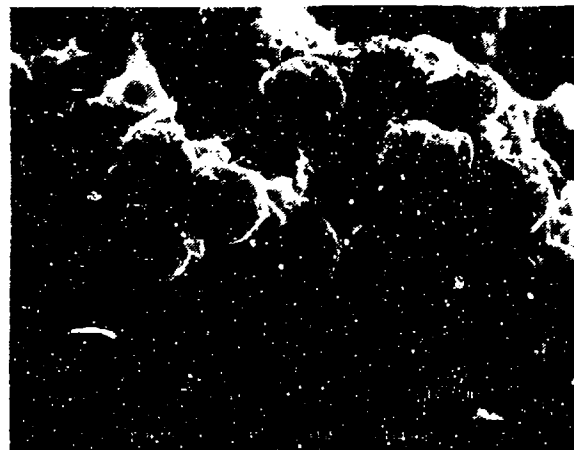
Fracture type	Translaminar mode I tension
Ply layup	[0, 90]16S
Test type	Four-point bend
• Test conditions	Dry
• Fiber and fracture	
Material	Hercules 3501-6/177°C cure AS4 fibers

-65°F, dry

180°F, dry

270°F, dry

Figure 2-131. SEM Photographs of Translaminar Mode I Tension, 0/90 Fracture, -65, 180, 270 F/Dry (High Magnification)

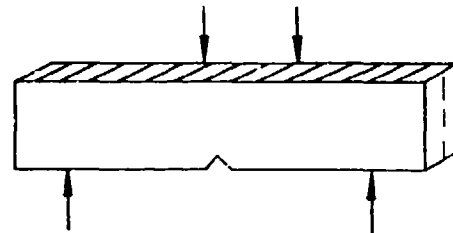
Fracture type	Translaminar mode I tension
Ply layup	[0, 90] _{16S}
Test type	Four-point bend
• Test conditions	Wet
• Fiber end fracture	
Material	Hercules 3501-6/177°C cure AS4 fibers

70°F, wet

180°F, wet

270°F, wet

Figure 2-132. SEM Photographs of Translaminar Mode I Tension, 0/90 Fracture, 70, 180, 270 F/Wet (50X)

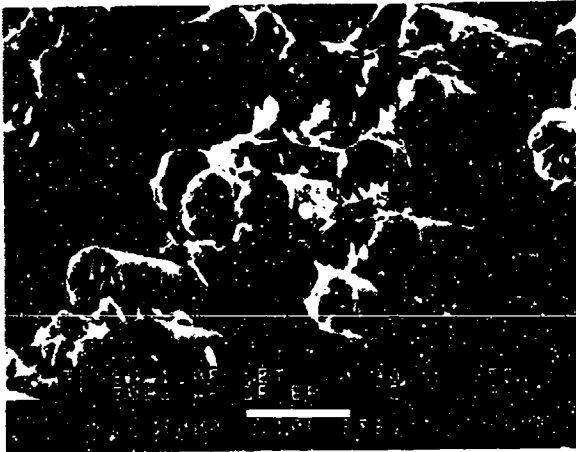
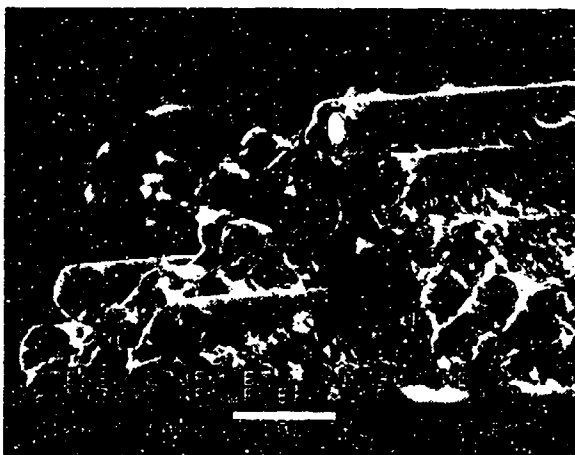
Fracture type	Translaminar mode I tension
Ply layup	[0, 90] ₁₆ S
Test type • Test conditions • Fiber end fracture	Four-point bend Wet
Material	Hercules 3501-6/177°C cure AS4 fibers

70°F, wet

180°F, wet

Mechanically induced crack direction

270°F, wet

Figure 2-133. SEM Photographs of Translaminar Mode I Tension, 0/90 Fracture, 70, 180, 270 F/Wet (2000X)

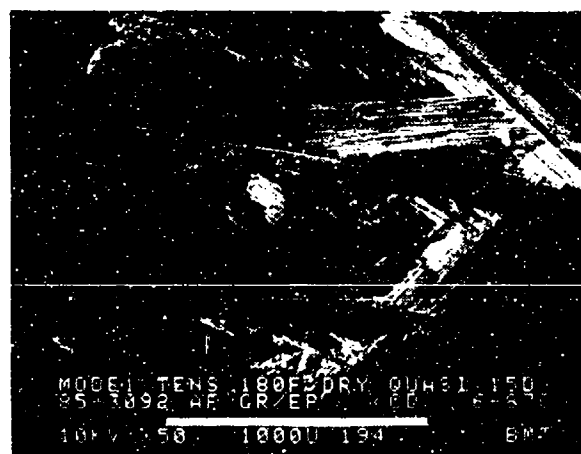
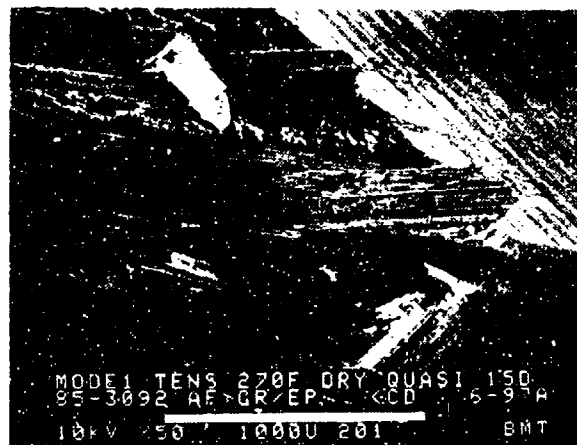
Fracture type	Translaminar mode I tension
Ply layup	[0, 45, 90] _{16S}
Test type	Four-point bend
• Test conditions	Dry
• Fiber end fracture	
Material	Hercules 3501-6/177°C cure AS4 fibers

-65°F, dry

180°F, dry

Mechanically induced crack direction

270°F, dry

Figure 2-134. SEM Photographs of Translaminar Mode I Tension, 0/45/90 Fracture, -65, 180, 270 F/Dry (50X)

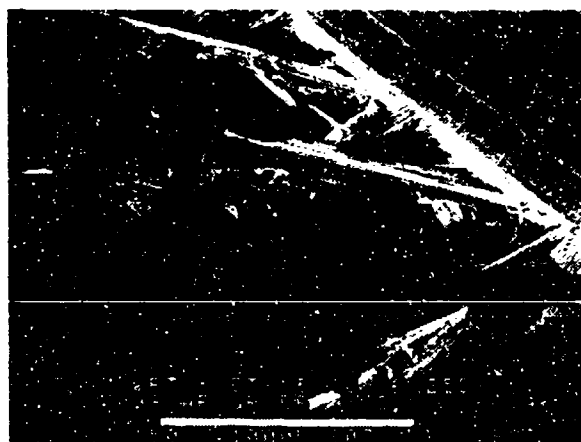
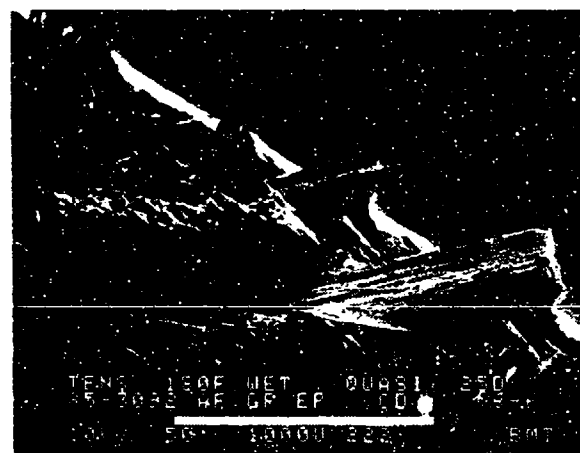
Fracture type	Translaminar mode I tension
Ply layup	[0, 45, 90] _{16S}
Test type	Four-point bend
• Test conditions	Wet
• Fiber end fracture	
Material	Hercules 3501-6/177°C cure AS4 fibers

70°F. wet

180°F. wet

Mechanically Induced crack direction

270°F. wet

Figure 2-136. SEM Photographs of Translaminar Mode I Tension, 0/45/90 Fracture, 70, 180, 270 F/Wet (50X)

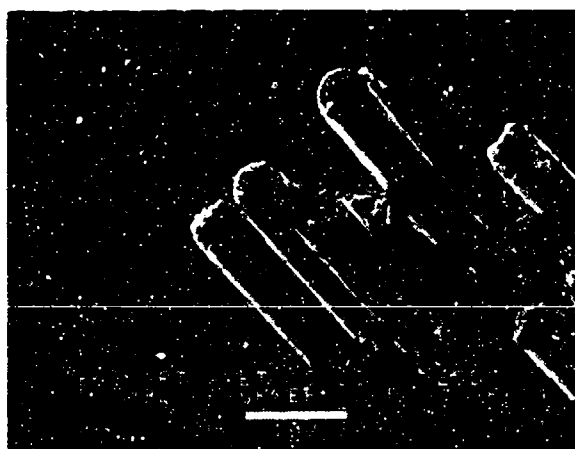
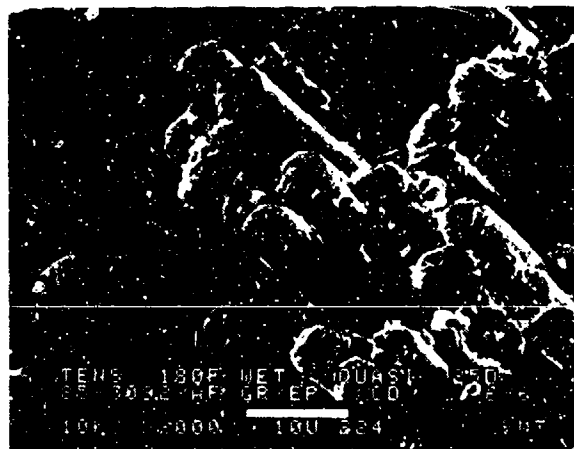
Fracture type	Translaminar mode I tension
Fiber layup	[0, 45, 90] _{16S}
Test type	Four-point bend
• Test conditions	Wet
• Fiber end fracture	
Material	Hercules 3501-6/177°C cure AS4 fibers

← Mechanically induced crack direction

70°F, wet

180°F, wet

270°F, wet

Figure 2-137. SEM Photographs of Translaminar Mode I Tension, 0/45/90 Fracture, 70, 180, 270 F/Wet (2000X)

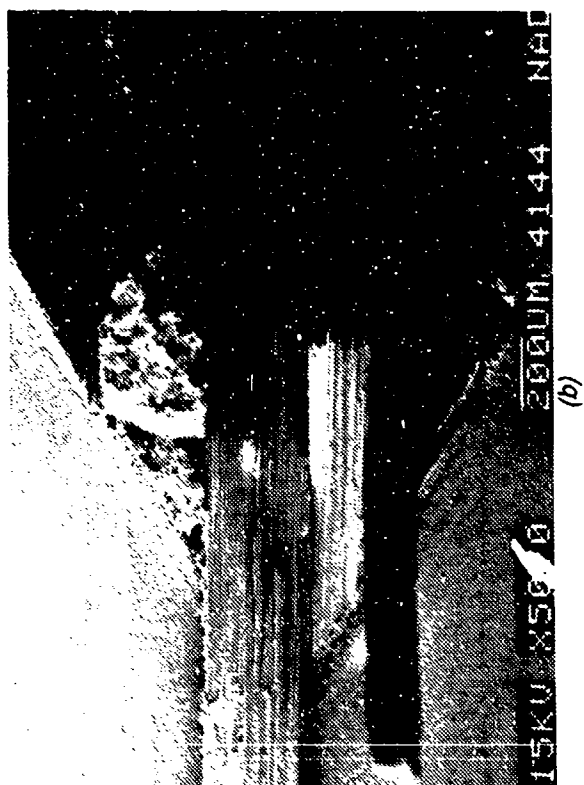
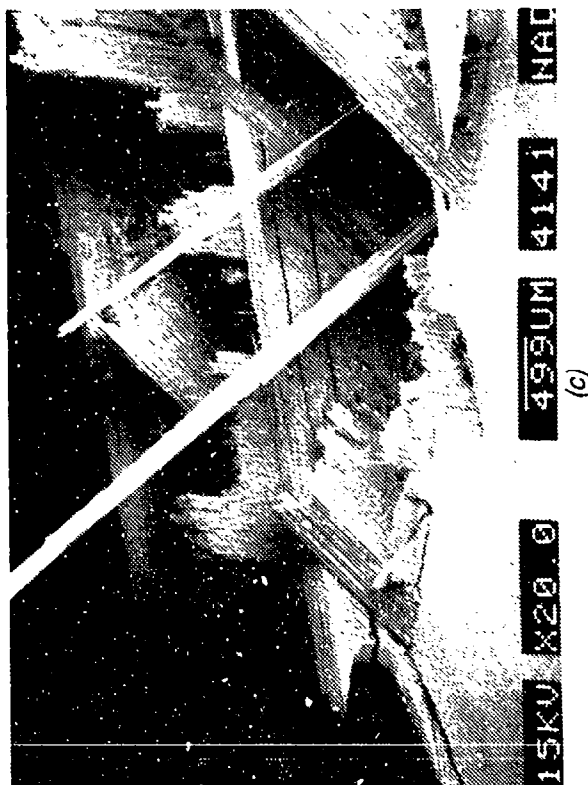
Figure 2-138. Optical and SEM Photographs of Translaminar Tension Fracture in Filament Wound Gr/Ep - 32 Ply/Quasi-Isotropic
(a) Macro photograph of Fractured Fragments
(b), (c) Normal and Oblique Views of Fracture Near the Apex

CD = Crack-propagation direction

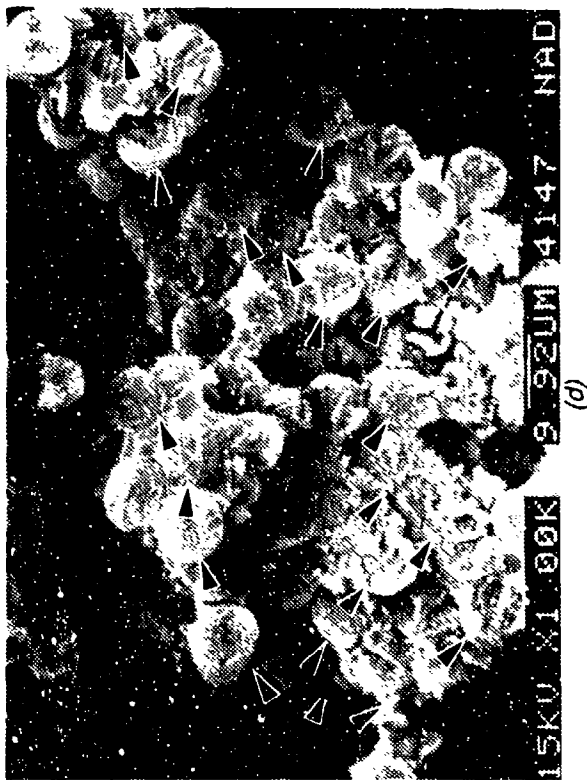
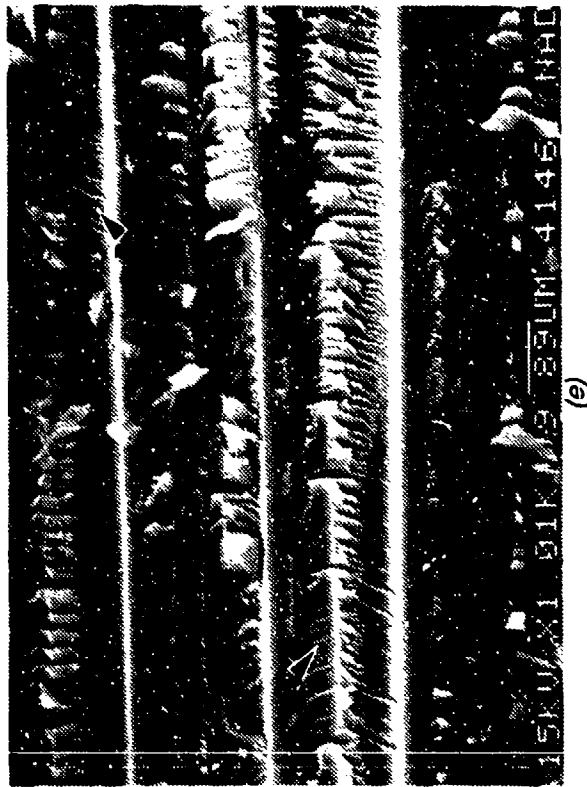
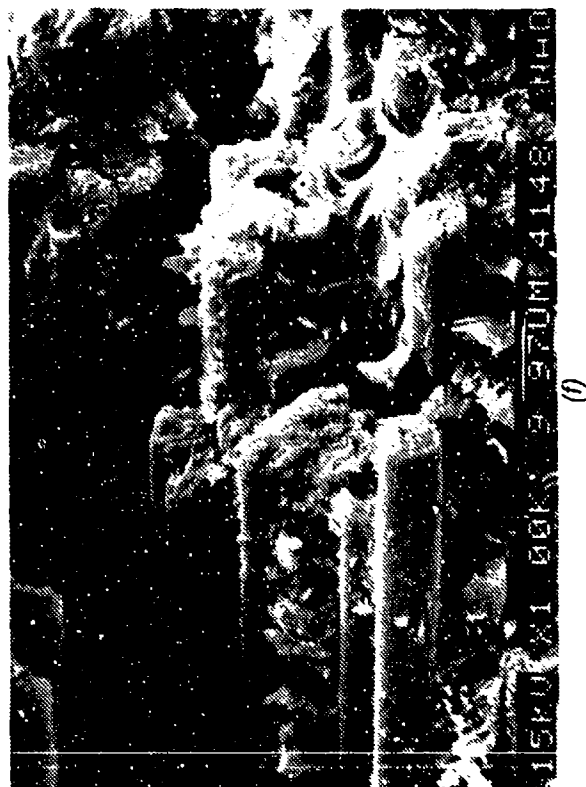
CD
↑

Figure 2-138. (Continued)
 (d) Arrows Point to DAF Radial Lines on Fractured
 Fiber-Ends and Indicate Local Fracture Path
 (e), (f) Fracture Features Present in Ply Orientation
 Parallel to Fracture
 Note hackles (H) and river patterns (R)
 CD = Crack-propagation direction

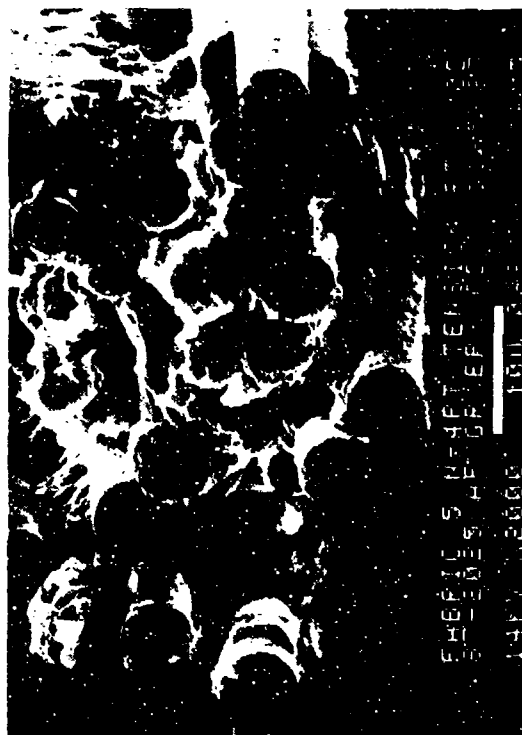
Mechanically induced
crack direction

0 degree tilt (d) Illustration of crack mapping using the radial patterns on the fiber ends 2,000X

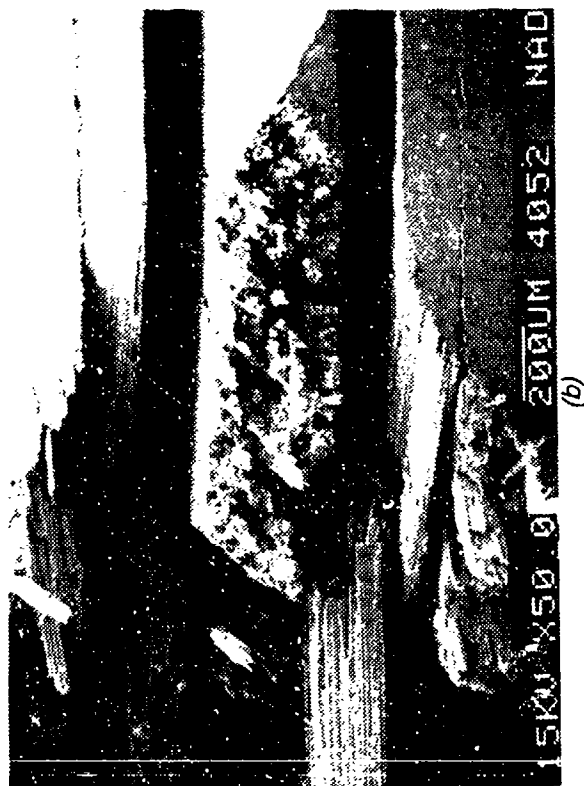
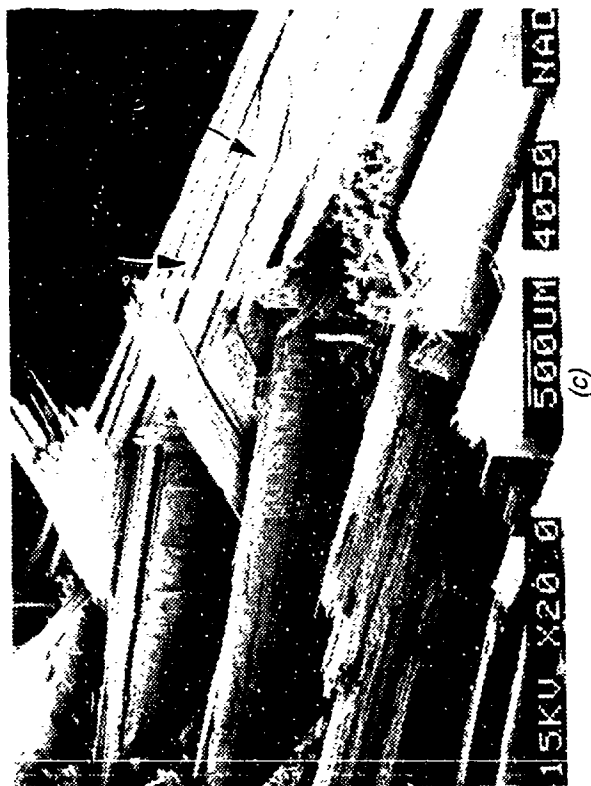
Figure 2-140. Optical and SEM Photographs of Translaminar Tension Fracture in Impact Damaged Gr/Ep -32 Ply/Quasi-Isotropic

(a) Macro photograph of Fractured Fragments

Arrows indicate damage zone

(b), (c) Normal and Oblique Views of Fracture Near the Apex

1 = Impact point

CD = Crack-propagation direction

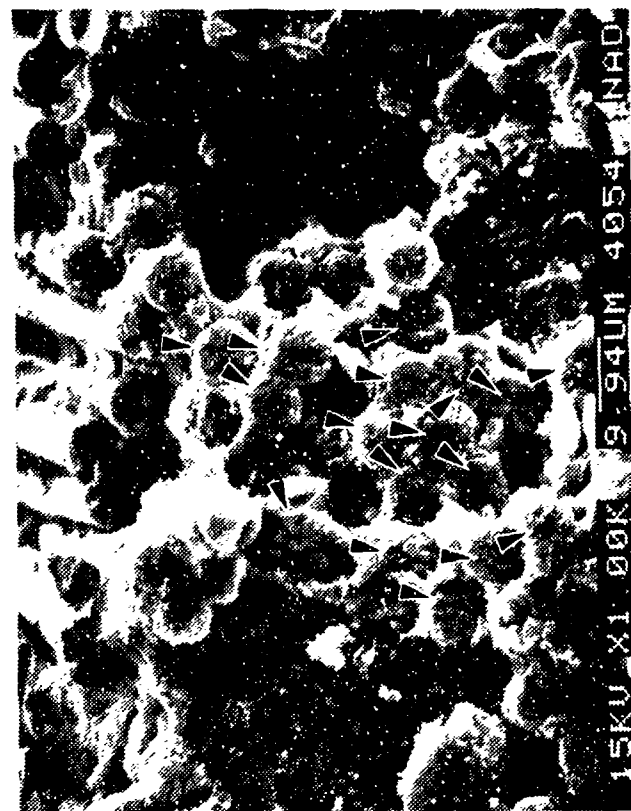
Figure 2-140. (Continued)
 (d) Arrows Point to DAF Radial Lines on Fractured Fiber-Ends and
 Indicate Local Fracture Path
 (e) Fracture Features Present in Ply Oriented Parallel to Fracture
 H = Hackles
 R = River patterns
 CD = Crack propagation direction

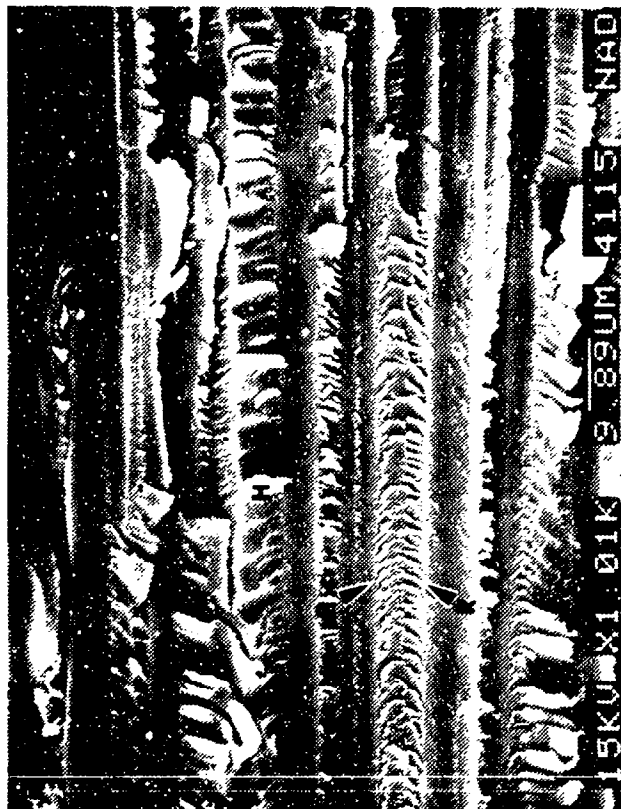
Figure 2-141. (Continued)
 (d) Arrows Point to DAF Radial Lines on Fractured Fiber-Ends and Indicate Fracture Path
 (e) Fracture Features Present in Ply Oriented Parallel to Fracture
 H = Hackles
 R = River patterns
 CD = Crack-propagation direction

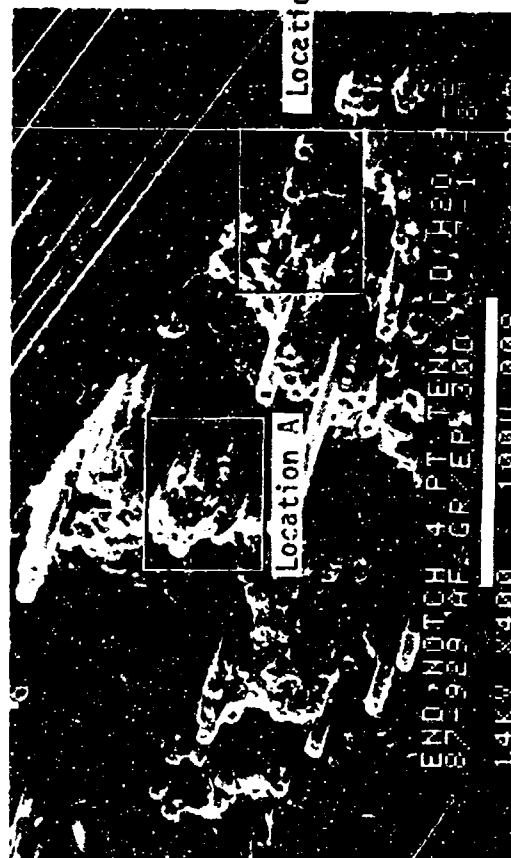
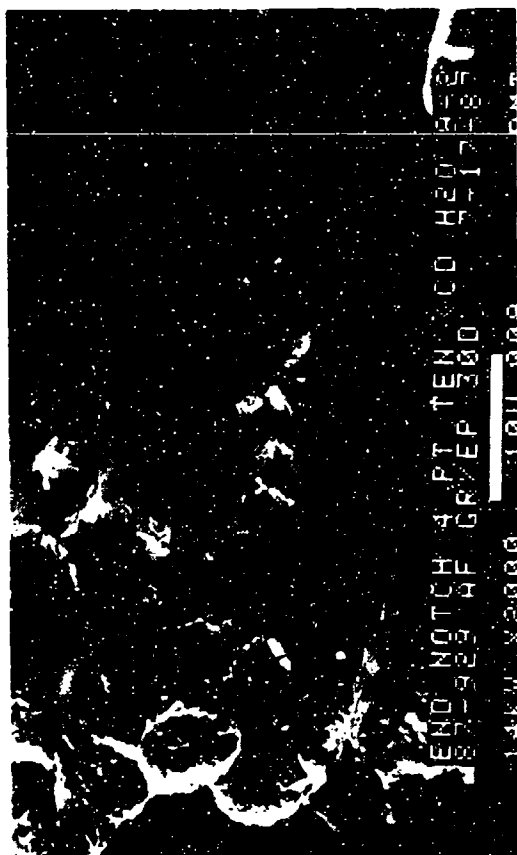
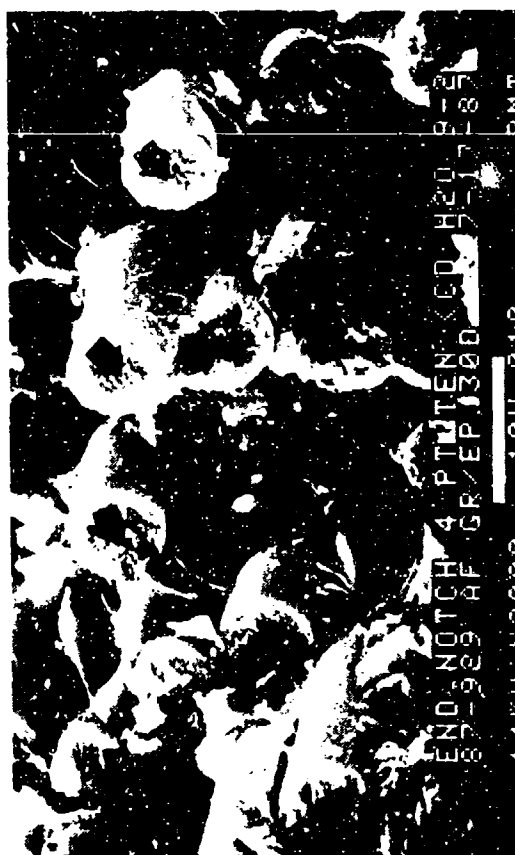
Figure 2-142. SEM Fractographs of Translaminar Tension, 0/90 Fracture, Water Immersion (160 F) After Test

30 degree tilt (c) Typical fracture along the fibers 2,000X

30 degree tilt (d) Illustration of crack mapping using the radial patterns on the fiber ends 2,000X

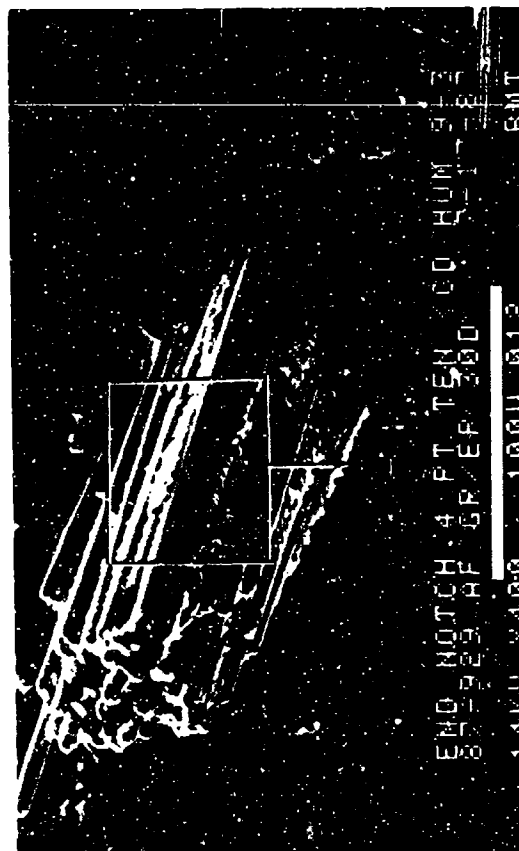
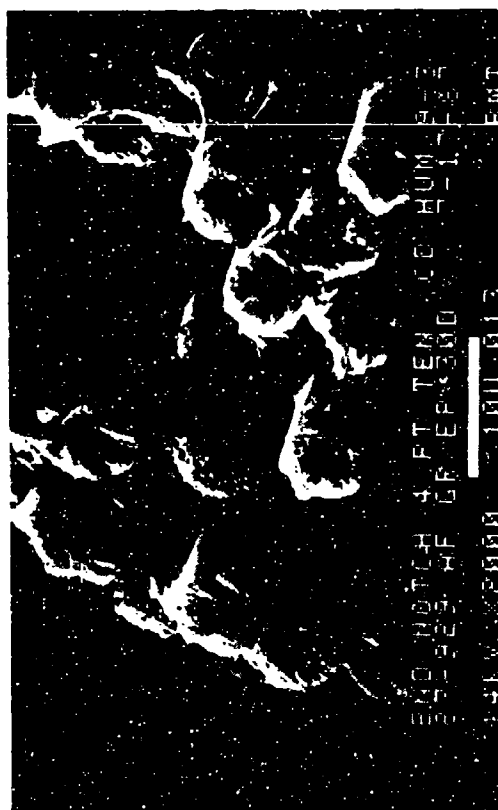
Illustration of crack mapping using
the radial patterns on the fiber ends

Figure 2-143. SEM Fractographs of Translaminar Tension, 0/90 Fracture, 100% Relative Humidity (160 F) Exposure After Test

30 degree tilt

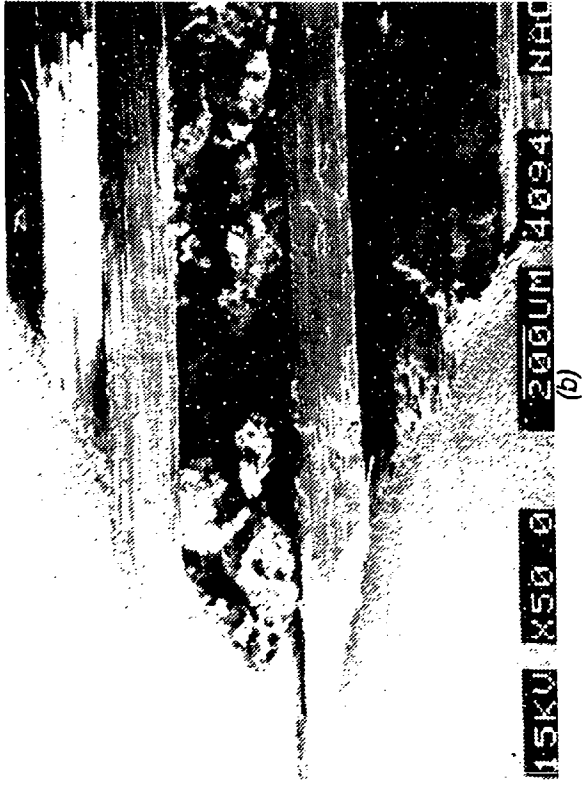
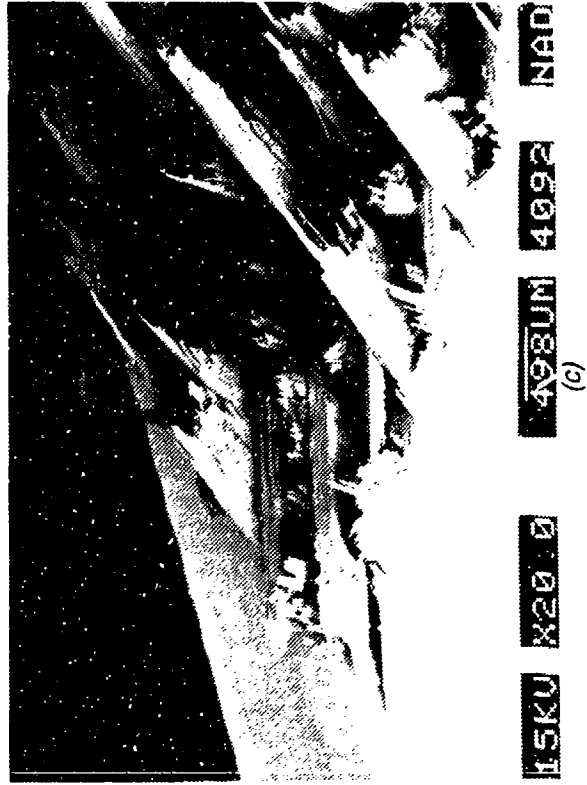
Optical photograph of fractured fragments. The image shows a dark, rectangular specimen with a bright, irregular fracture line.

Figure 2-144. Optical and SEM Photographs of Translaminar Tension Fracture in Undercured Gr/Ep -32 Ply/Quasi-Isotropic
(a) Macro photograph of fractured fragments
(b), (c) Normal and Oblique Views of Fracture Near the Apex

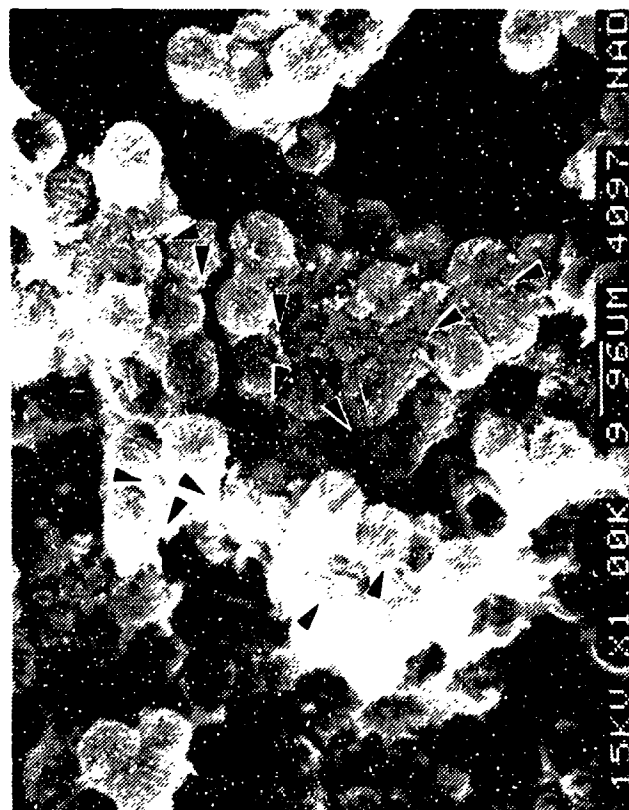
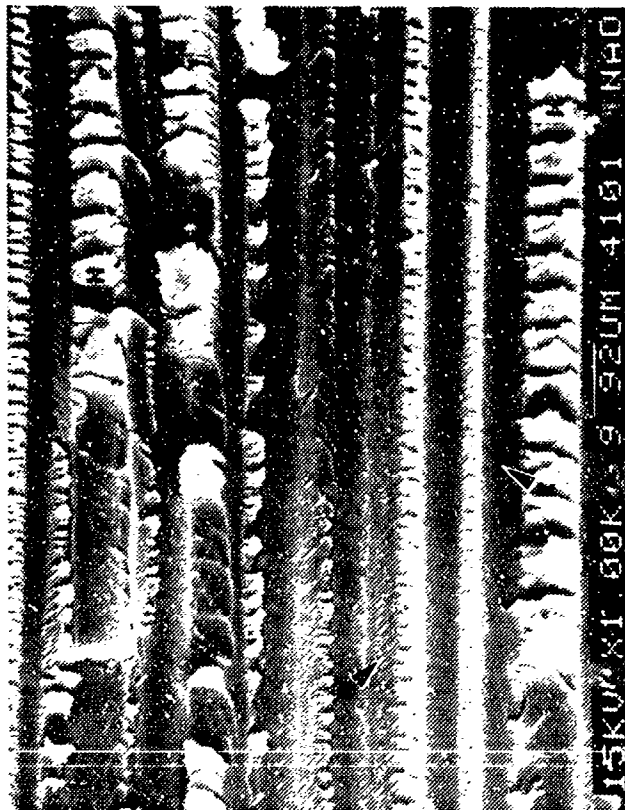
Figure 2-144. (Continued)
 (d) Arrows Point to DAF Radial Lines on Fractured Fiber-Ends and Indicate Fracture Path
 (e) Fracture Features Present in Ply Oriented Parallel to Fracture

H = Hackles
 R = River patterns
 S = Scallops

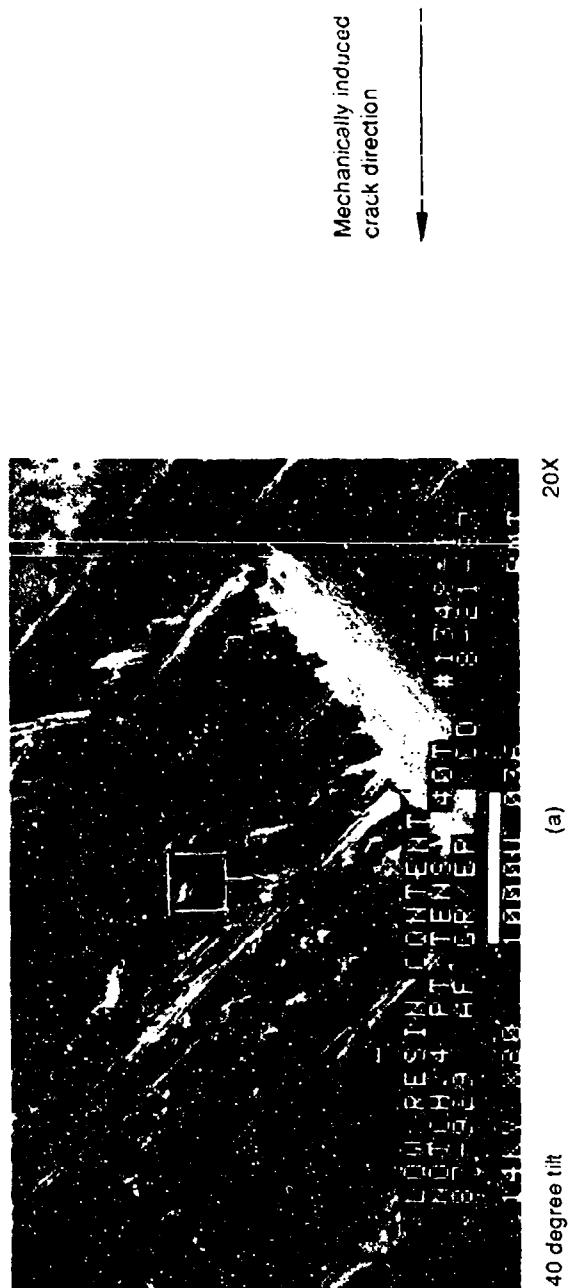
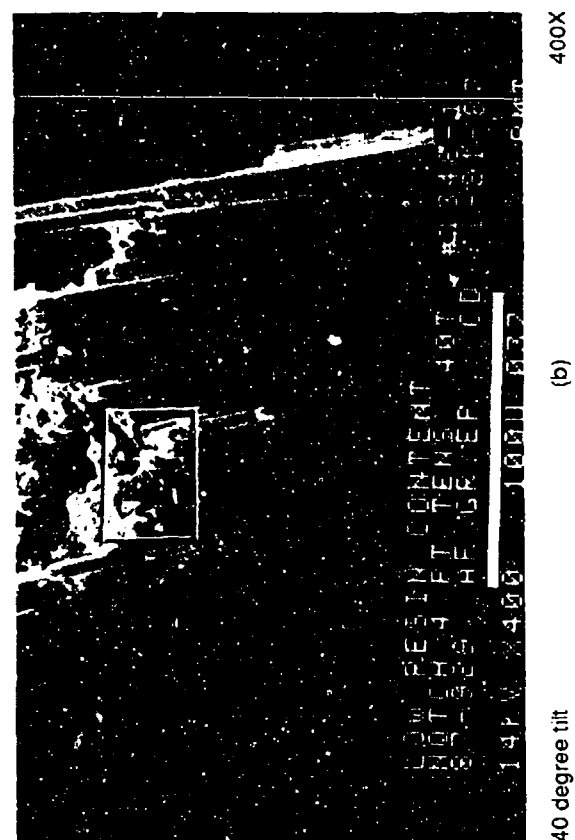
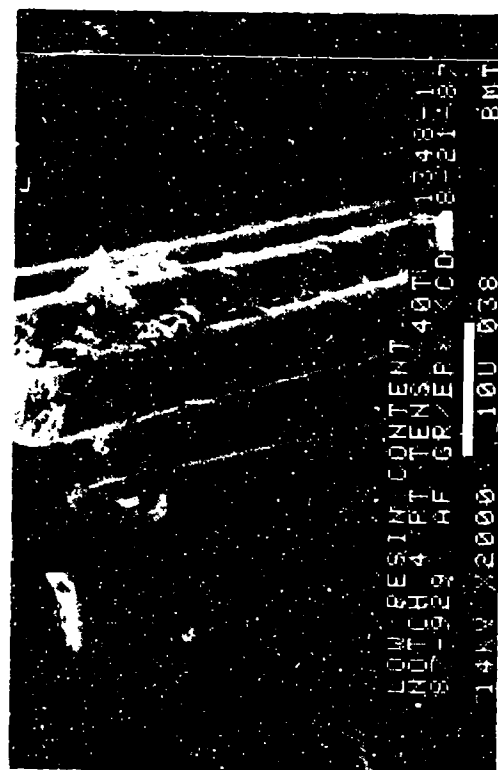
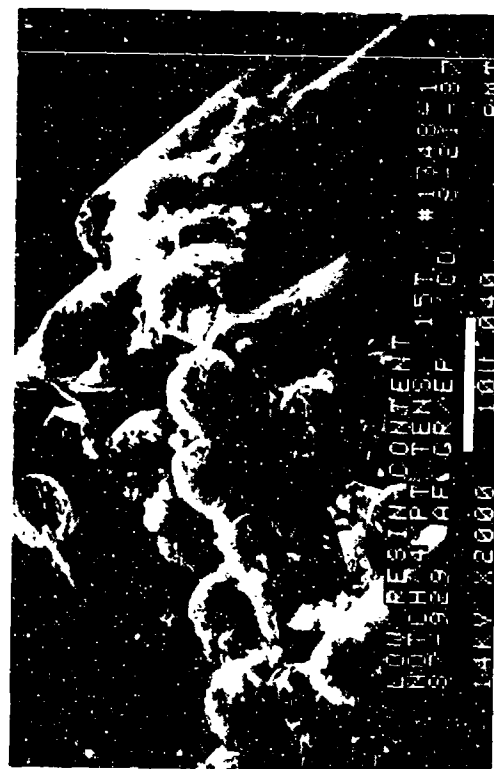
Figure 2-145. SEM Fractographs of Translaminar Tension, 0/90 Fracture, Low Resin Content

40 degree tilt (c) Typical fracture along the fibers 2,000X

15 degree tilt (d) Illustration of crack mapping using the radial patterns on the fiber ends 2,000X

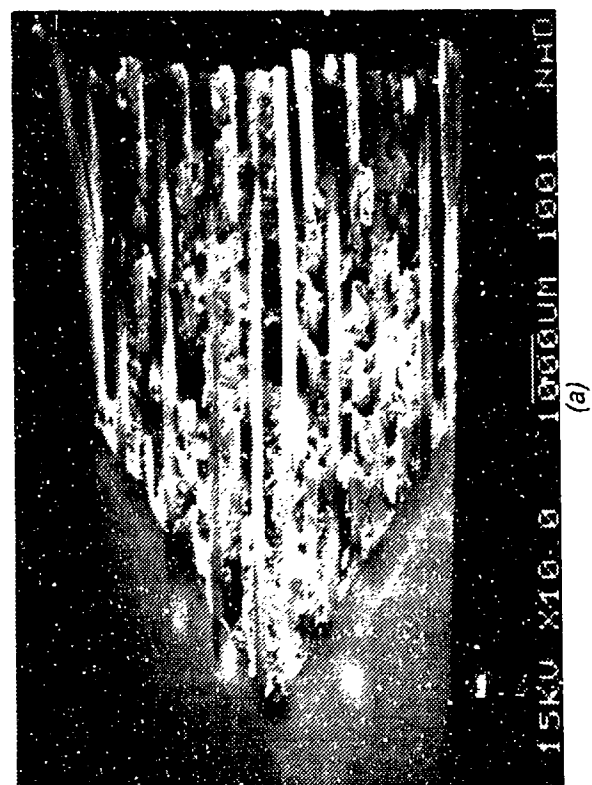
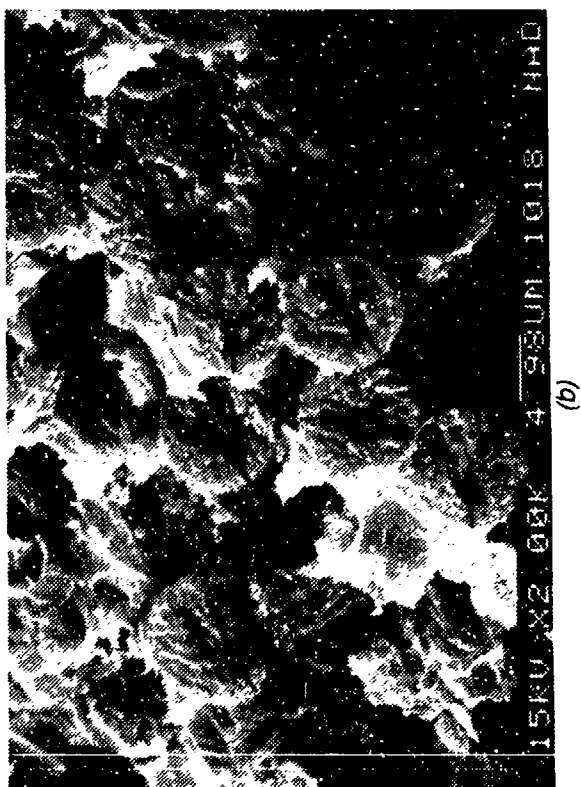
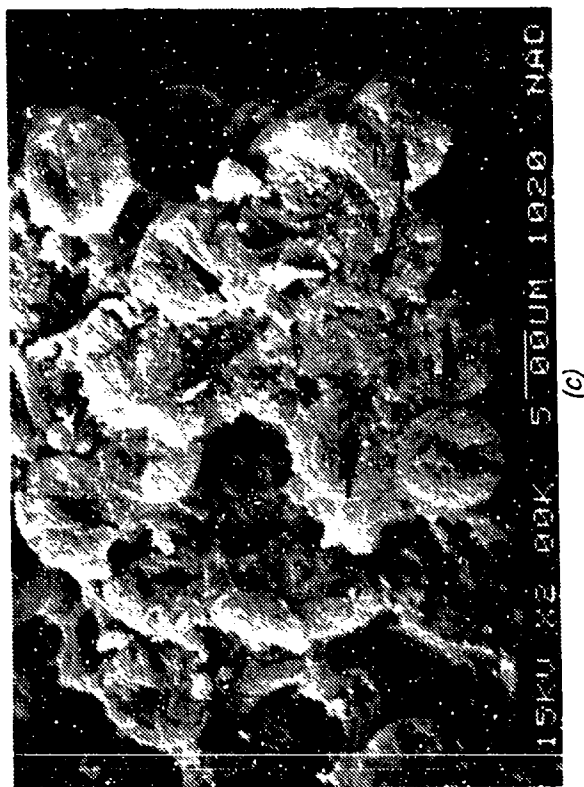
Figure 2-146. SEM Photographs of Translamellar Tension Fracture in High Resin Content Gr/Ep - 32 Ply Quasi-Isotropic (a), (b) River Patterns (Arrows) in Fractured Epoxy Region of a 90 Degree Ply (c) Hackles (H), Scallops (S), and Broken Fibers in a 45 Degree Ply

CD = Crack-propagation direction

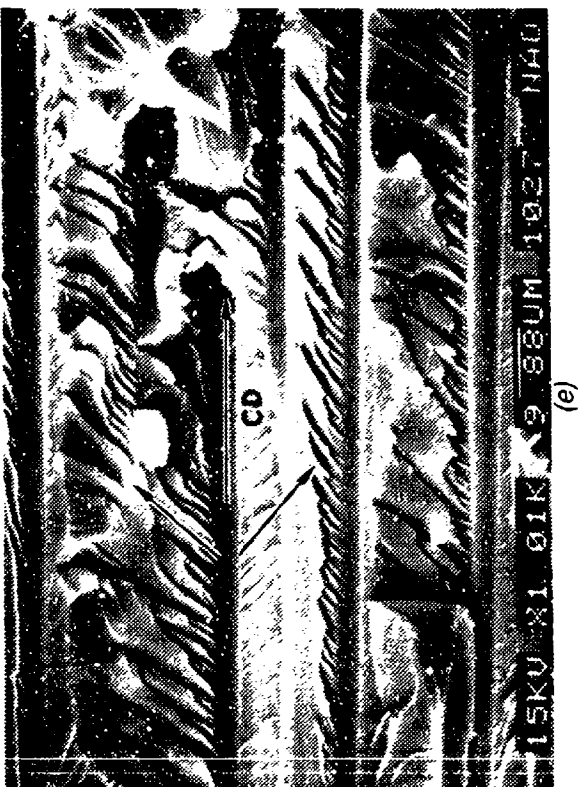
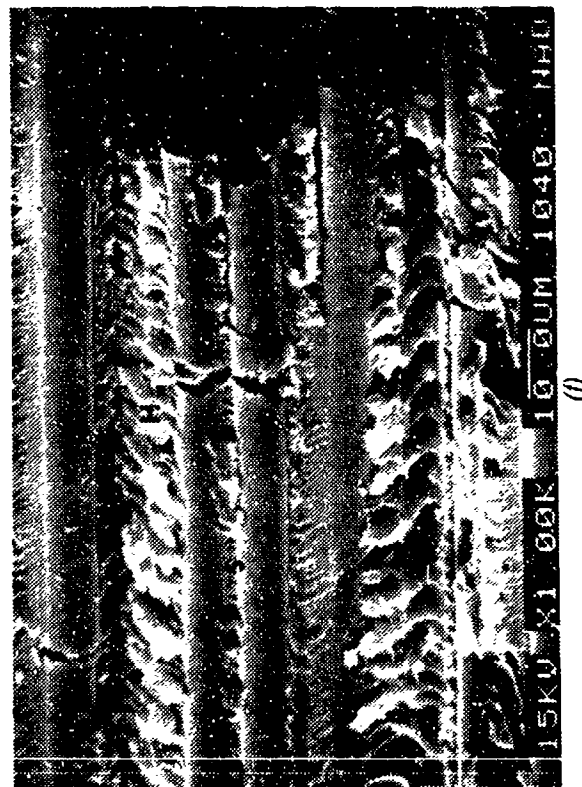
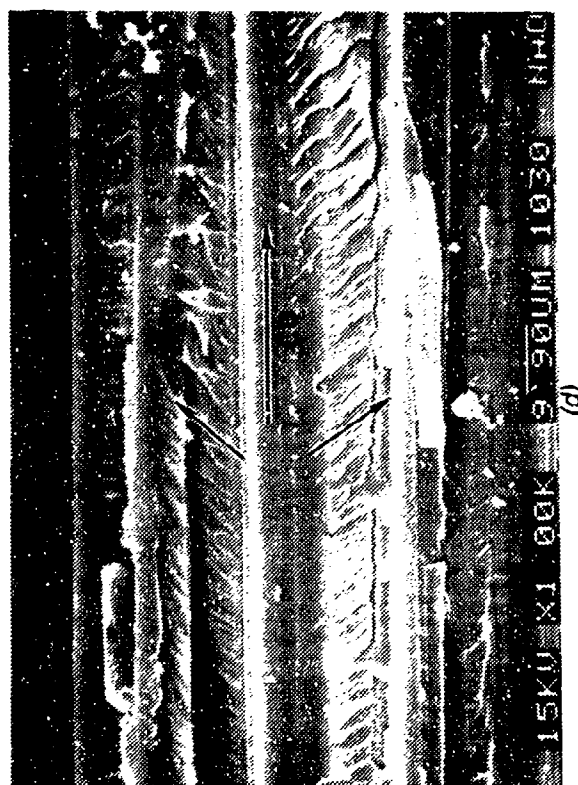
Figure 2-146. (Continued)
(d), (e) River Patterns (Arrows) Present in the
Fractured Epoxy Regions of a 90 Degree Ply
(f) Hackles (H), Scallops (S), and Broken Fibers in a
45 Degree Ply

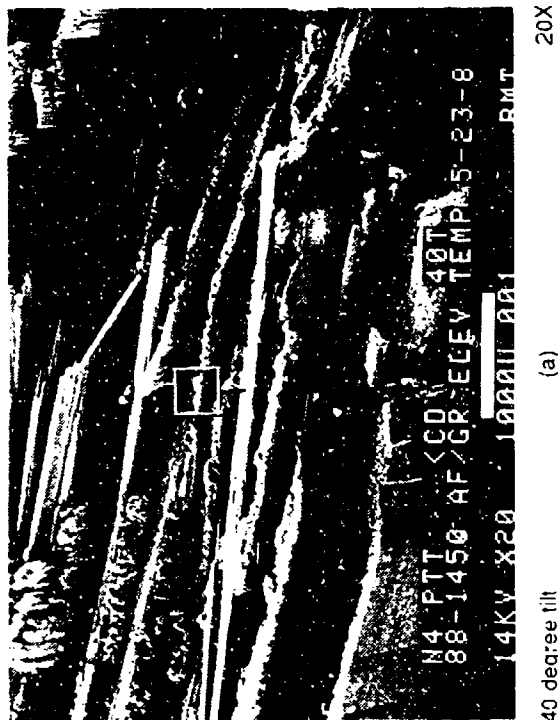
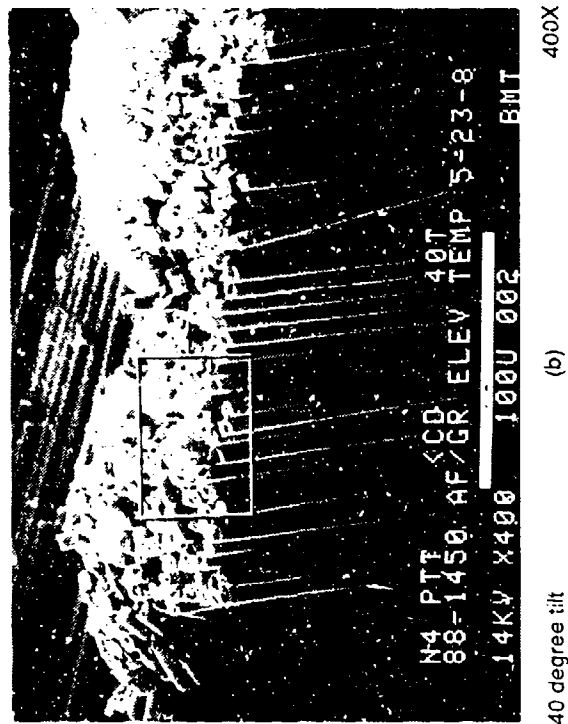
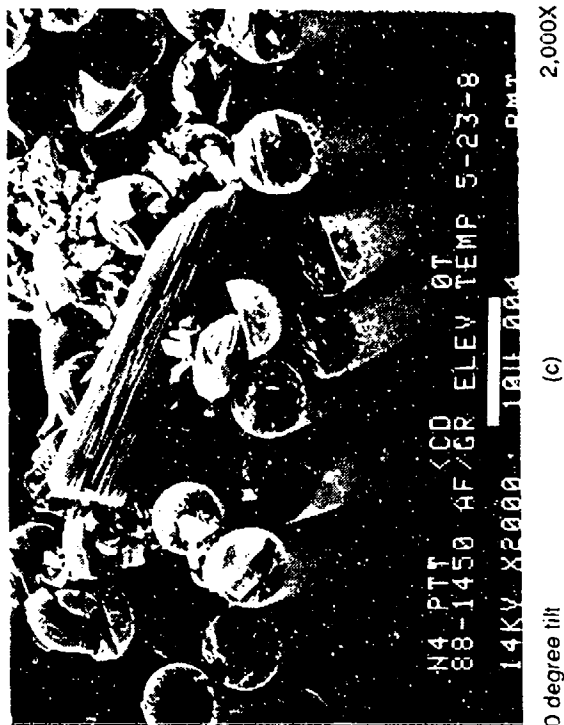
Figure 2-147. SEM Fractiographs of Translaminar Tension, 0/90 Fracture, 2000 F Exposure for 5 Minutes After Test

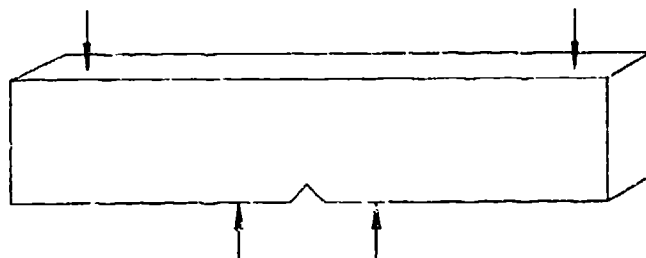
Figure 2-148. Four-Point Bend Test Type

Figure 2-148 shows the translaminar compression test configuration. Translaminar compression fracture usually occurs by a combination of fiber microbuckling and delamination fractures. Chop marks on the fiber ends (Figure 2-149) indicate a flexural fiber fracture. Studies of the neutral axis lines of the chop marks have indicated that no direct correspondence to crack propagation is inferred.

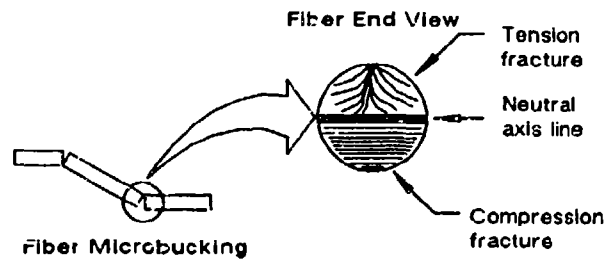
Figure 2-149. Translaminar Compression Fracture

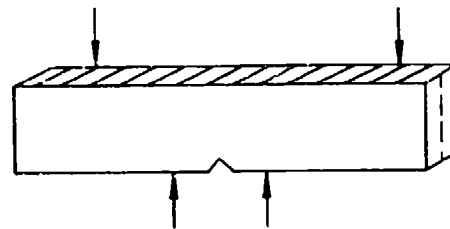
Fracture type	Translaminar mode I compression
Ply layup	[0] 32
Test type	Four-point bend
• Test conditions	21°C, dry
• Fiber end fracture	
Material	Hercules 3501-6/177°C cure AS4 fibers

Figure 2-150. SEM Photographs of Translaminar Mode I Compression, 0/0 Fracture, 70 F/Dry

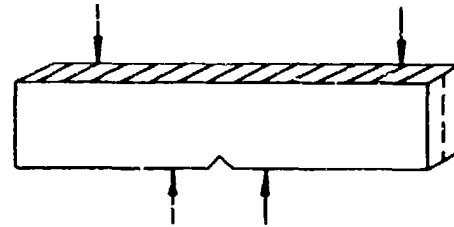
Fracture type	Translaminar mode I compression
Ply layup	[0] 32
Test type	Four-point bend
• Test conditions	Dry
• Fiber end fracture	
Material	Hercules 3501-6/177°C cure AS4 fibers

Figure 2-151. SEM Photographs of Translaminar Mode I Compression, 0/0 Fracture.
-65, 180, 270 F/Dry (20X)

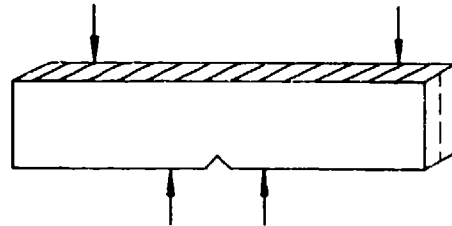
Fracture type	Translaminar mode I compression
Ply layup	[0] 32
Test type	Four-point bend
• Test conditions	Dry
• Fiber end fracture	
Material	Hercules 3501-6/177°C cure AS4 fibers

Figure 2-152. SEM Photographs of Translaminar Mode I Compression, 0/0 Fracture, -65, 180, 270 F/Dry (400X)

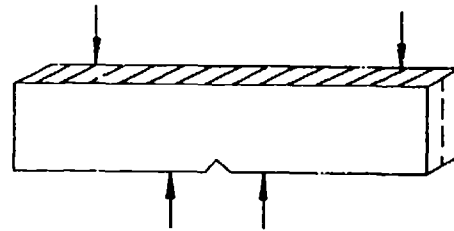
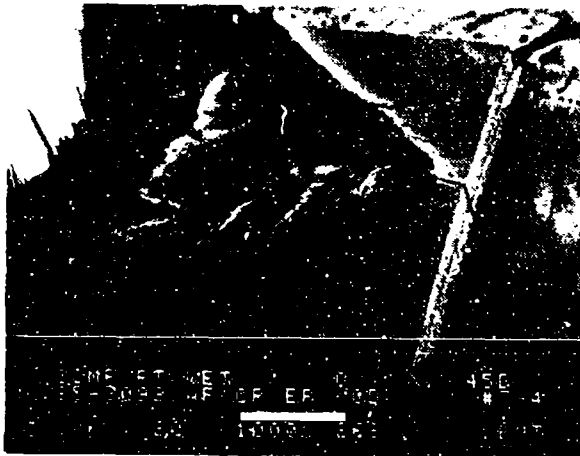
Fracture type	Translaminar mode I compression
Ply layup	[0] 32
Test type	Four-point bend
• Test conditions	Wet
• Fiber end fracture	
Material	Hercules 3501-6/177°C cure AS4 fibers

Figure 2-153. SEM Photographs of Translaminar Mode I Compression, 0/0 Fracture, 70, 180, 270 F/Wet (20X)

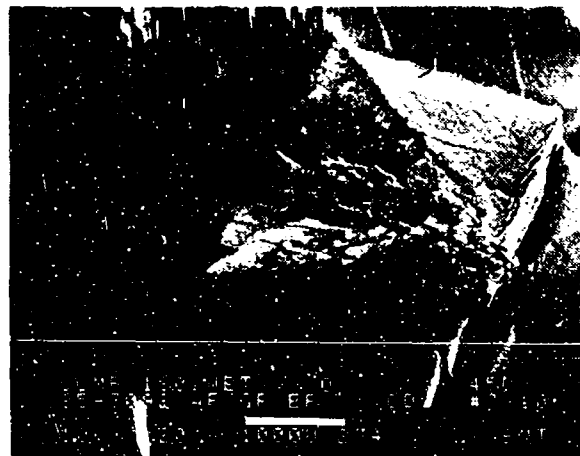
70°F, wet

180°F, wet

270°F, wet

The test matrix for this section is provided in Table 2-6. Figures 2-150 through 2-173 are the translaminar compression fractographs. The reader should note that the low-magnification SEM photomicrographs reveal both compression fracture (flat) and tension fracture (fibers protruding). This is because the flexural nature of the test specimen, where cracking is initiated at the notch in compression. The high magnification photographs are from the compression fracture region. The fractography figures are arranged in the same order that the corresponding tests are listed in Table 2-6.

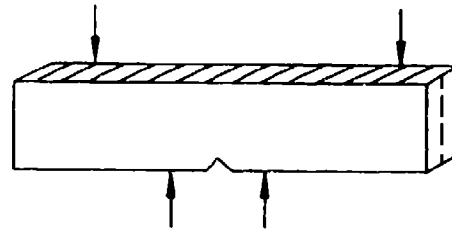
Fracture type	Translaminar mode I compression
Ply layup	[0] ₃₂
Test type	Four-point bend
• Test conditions	Dry
• Fiber end fracture	
Material	Hercules 3501-6/177°C cure AS4 fibers

70°F, wet

180°F, wet

270°F, wet

Figure 2-154. SEM Photographs of Translaminar Mode I Compression, 0/0 Fracture, 70, 180, 270 F/Wet (400X)

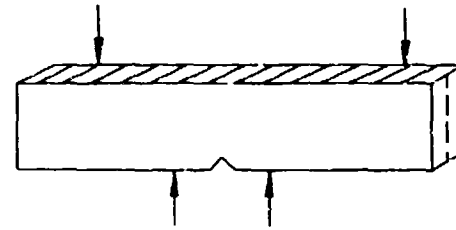
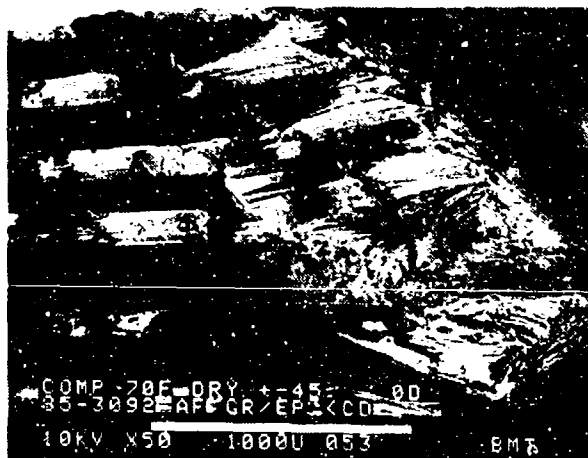
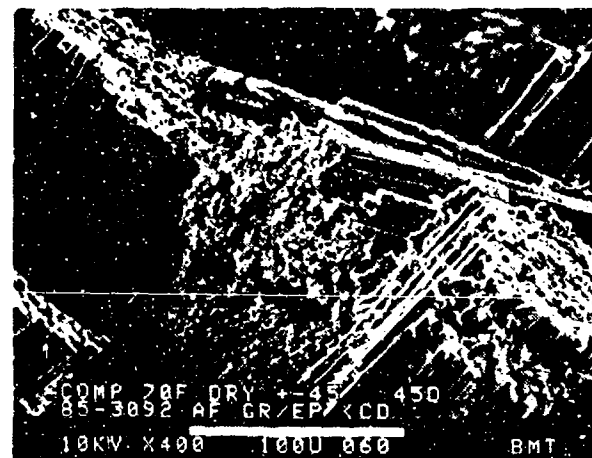
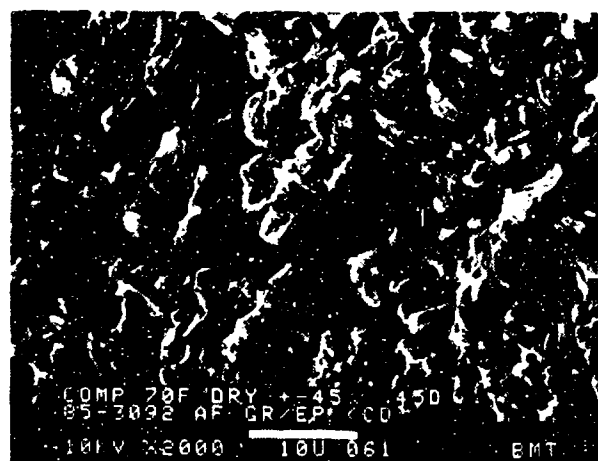
Fracture type	Translaminar mode I compression
Ply layup	[+45, -45] 16S
Test type	Four-point bend
• Test conditions	21°C, dry
• Fiber end fracture	
Material	Hercules 3501-6/177°C cure AS4 fibers

Mechanically induced crack direction

Figure 2-155. SEM Photographs of Translaminar Mode I Compression, +45/-45 Fracture, 70 F/Dry
